## **An environmental catastrophe and its incorporation into the environmental engineering curriculum at the University of Pannonia**

**ABSTRACT:** Red mud storage, Cassette No. 10, ruptured on 4 October 2010 during the daytime in Hungary. About one million cubic metre of red mud sludge burst and covered a territory of about 1,017 hectares. The caustic sludge flooded the surrounding settlements and polluted the nearby Torna stream, which flows through the Marcal and Raba rivers into the Danube. The red mud sludge exhibits alkaline properties, therefore, this environmental disaster resulted in an extremely serious situation. Immediately after the catastrophe, the University of Pannonia, Veszprém, Hungary, set up an emergency response team to carry out environmental monitoring and to devise red mud sludge clean up technologies. This paper deals with the results of the environmental monitoring and the emergency measures taken and with the incorporation of this very serious event in the environmental impact assessment course programme. The key issues of the disaster, the history and the life cycle of the red mud reservoir are explained in detail. The processing and reutilisation of th

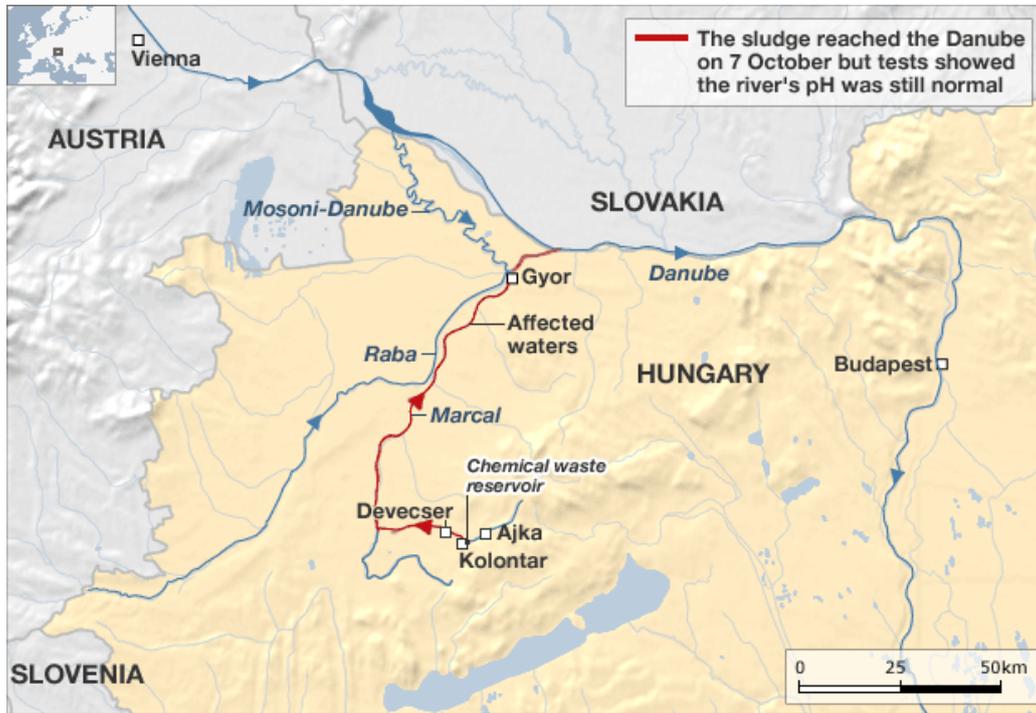
Figure 1: The catastrophe site near Ajka, Hungary, and the area contaminated by red sludge surface water from the Danube [4].

The containment wall of red mud waste reservoir (Cassette No. 10) burst on 4 October 2010 during the daytime in Hungary. The catastrophe occurred near Ajka in the Central Transdanubian Region, about 50 km from Lake Balaton and 130 km from Budapest. About one million cubic metre of red mud sludge spilled and covered a territory of about 1,017 hectares. The caustic sludge flooded three villages (Kolontár, Devecser, Somlóvásárhely) and contaminated the rivers and streams including the nearest, the Torna, which flows into the Marcal and Raba rivers into the Danube (Figure 1).

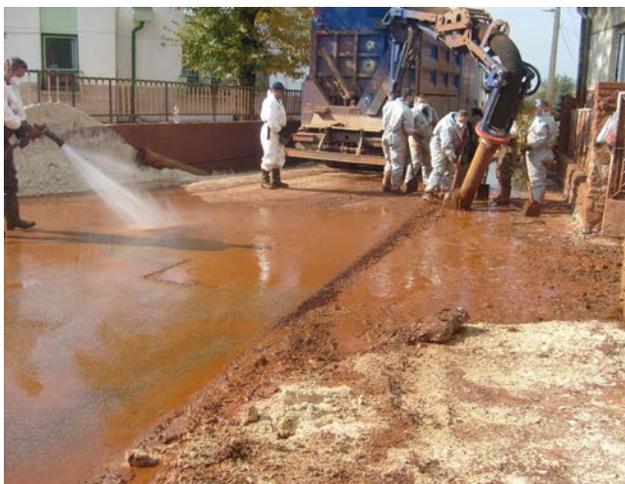
Figure 2: Students at the catastrophe site: a) taking part in cleanup and rehabilitation actions; b) taking soil samples at the residual area of the village of Kolontár.

Moreover, students of the environmental engineering programme worked voluntarily after the disaster with the emergency team, after being granted a special permit to work at the contaminated sites, and provided help in cleanup and rehabilitation operations (Figure 2a).
